# Evaluation Report 423

## Berglund Industrial Supply Company Combination Grain and Seed Cleaner

A Co-operative Program Between

## BERGLUND INDUSTRIAL SUPPLY CO. COMBINATION GRAIN AND SEED CLEANER

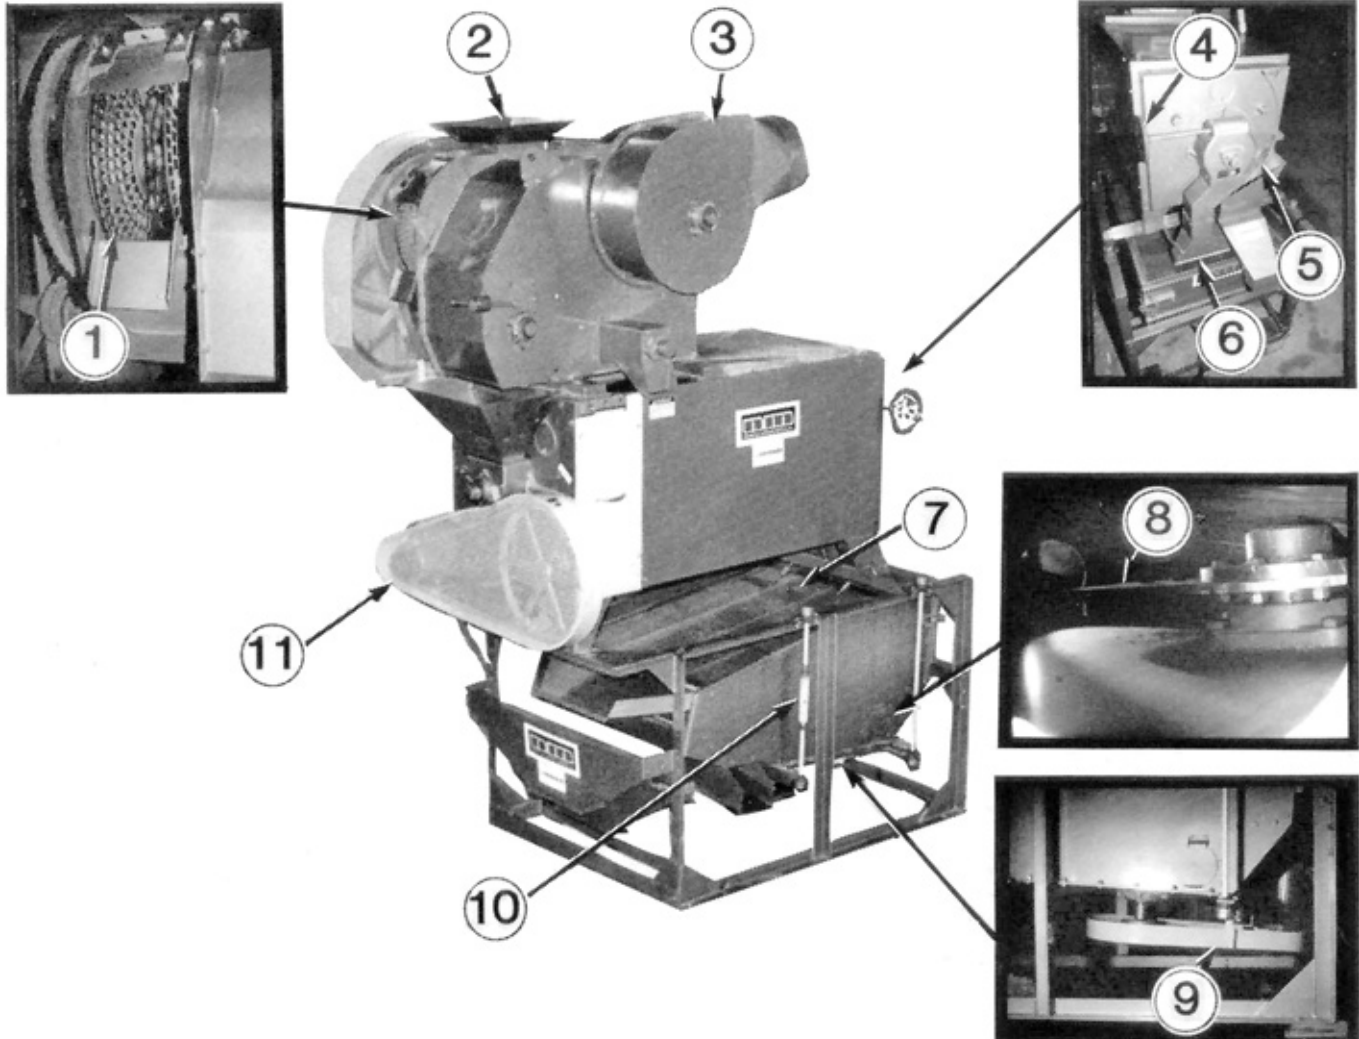
FIGURE 1. Bisco Cleaner: (1) Scalper Disks, (2) Inlet Hopper, (3) Centrifugal Fan, (4) Indent Cylinder Trough Adjustment, (5) Indent Cylinder Retarder, (6) Grain Distributor, (7) Screens, (8) Counter Balance Weight, (9) Eccentric Drive System, (10) Screen Slope Adjustment, (11) Indent Cylinder Drive System.

The Bisco Combination Seed Cleaner is a solidly constructed, small capacity grain cleaner incorporating three cleaning sections. Each section can be removed from the machine and operated separately. Grain is separated by weight, width and length. These functions are performed by scalper disks, a fan, an indent cylinder and two different screenings (FIGURE 1).

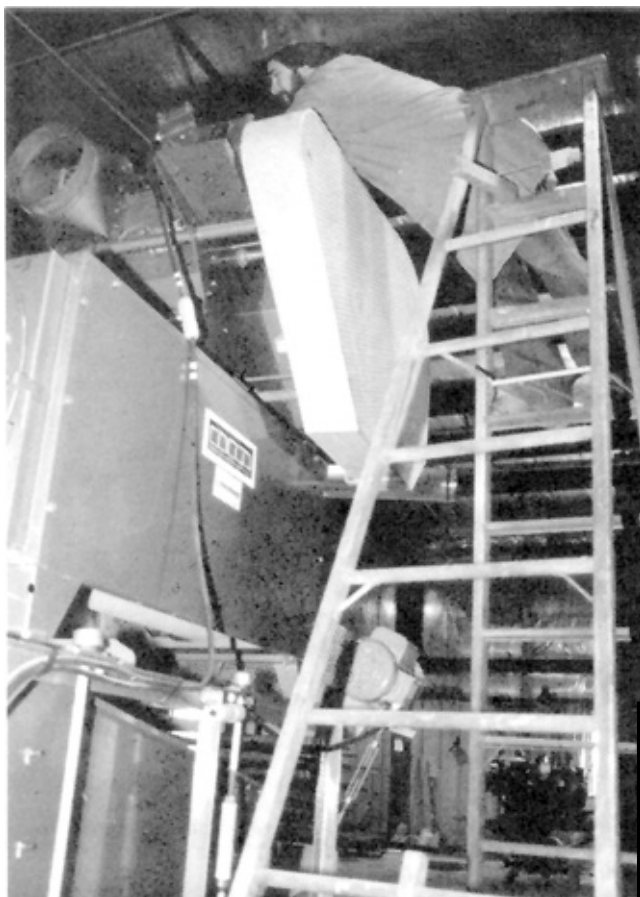
Generally most adjustments were easily accomplished. However, the controls on the aspirator section on the top of the machine were difficult to reach, requiring the operator to use a ladder (FIGURE 5) and was potentially hazardous.

FIGURE 5. Adjusting Aspirator Controls.

The Bisco Combination Grain and Seed Cleaner was safe to operate if normal precautions were observed. Belts and pulleys were well shielded. However, the operator had to be extra cautious when adjusting controls on the aspirator section (FIGURE 5) because of the height of the machine. Also, no safety decals were provided on the test machine. It is recommended that the manufacturer consider providing safety decals to alert the operator of potentially hazardous areas.

5. Modifying the aspiration controls for easier access.
6. Rewriting the operator's manual to include information on operation, adjustment, safety and service for all sections of the machine.

5. Recommendation #5 has now been corrected to have the feed control rod at the top of the sieve unit approximately 4 feet above ground level.
6. Currently we are re-working the manual to include operating instructions and parts lists. This will be forwarded upon completion.

It is recommended that the manufacturer consider modifying the aspirator controls for easier access. The volume of air, the draft and the amount of grain falling from the covered cross auger could be controlled.
